EFFECTS OF THE ATOMIC BOMB ON NAGASAKI,
JAPAN

Physical Damage Division

JUNE 1947

13 October-20 November 1945

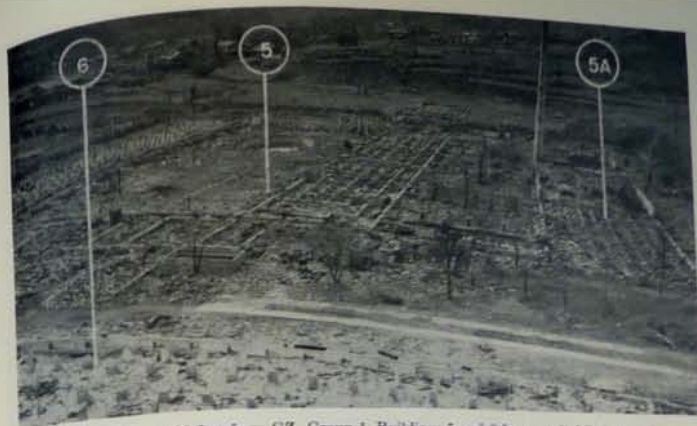
PHOTO 1.—5,900 feet from GZ. Group 1, Buildings 5 and 6 from roof of Building 7.

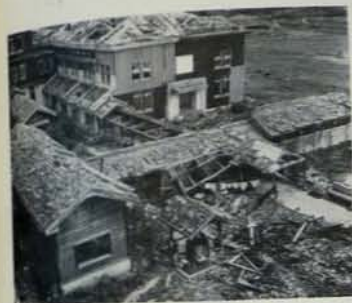
PHOTO 2.—Group 1, south courtyard, Building 7.

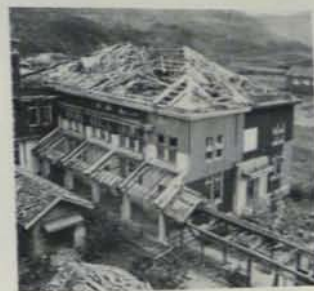
PHOTO 3.—Group 1, damage to roof of Building 7A.

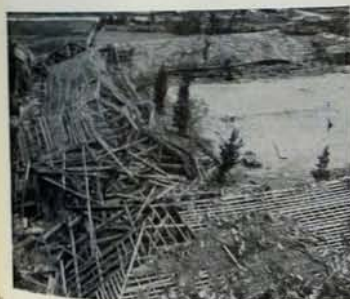
PHOTO 4.—Group 1, view of collapsed roof of Building 9.

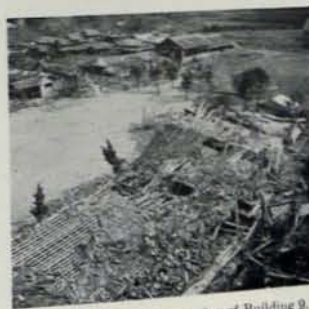
PHOTO 5.—Group 1, west wing of Building 9.

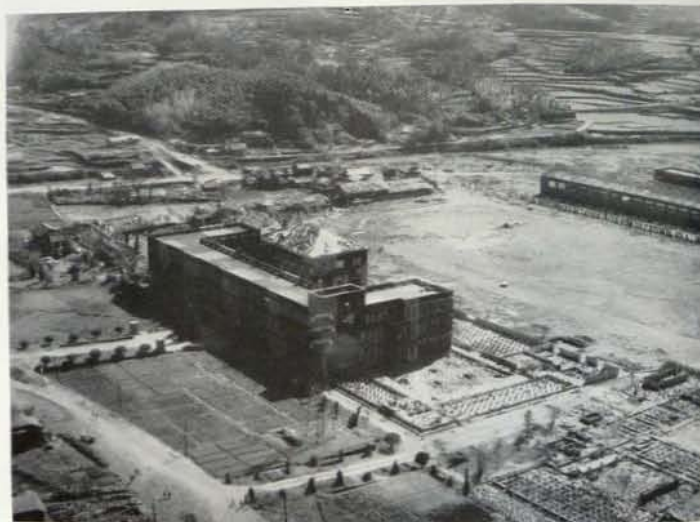
PHOTO 7.—5000 feet from GZ. Group 1, aerial view of Building 7.

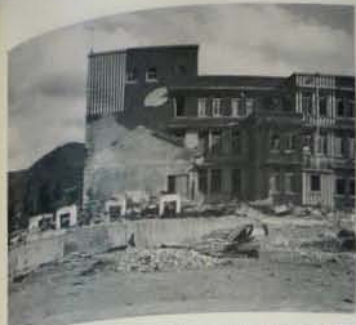
PHOTO 8.—3,900 feet from GZ. Group 1, west side of Building 7.

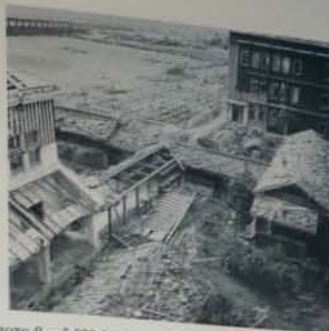
PHOTO 9.—5,900 feet from GZ. Group 1, courtyard south of Building 7.

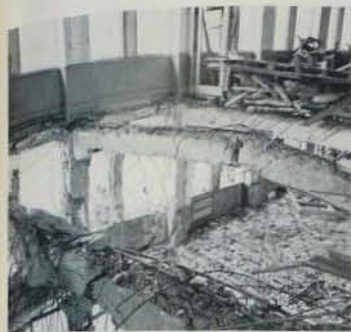
PHOTO 10.—Group 1, high-explosive bomb damage to third floor, Building 7.

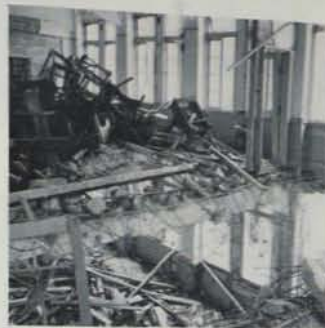
PHOTO 11.—Group 1, high-explosive bomb damage to third floor, Building 7.

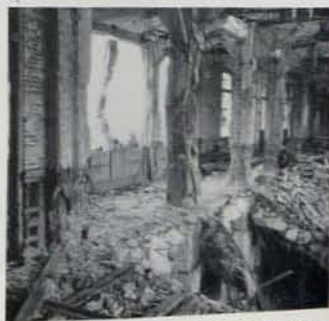
PHOTO 13.—Group 1, high-explosive bomb damage to second floor, Building 7.

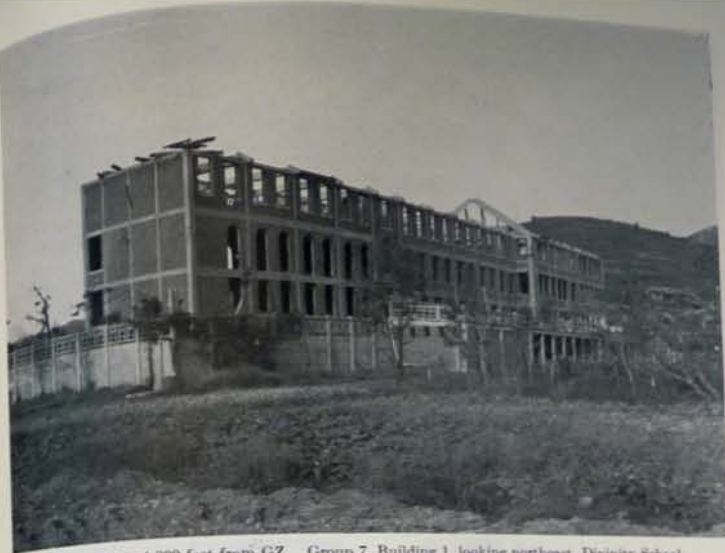
PHOTO 16.—4,800 feet from GZ. Group 7, Building 1, looking northeast, Divinity School.

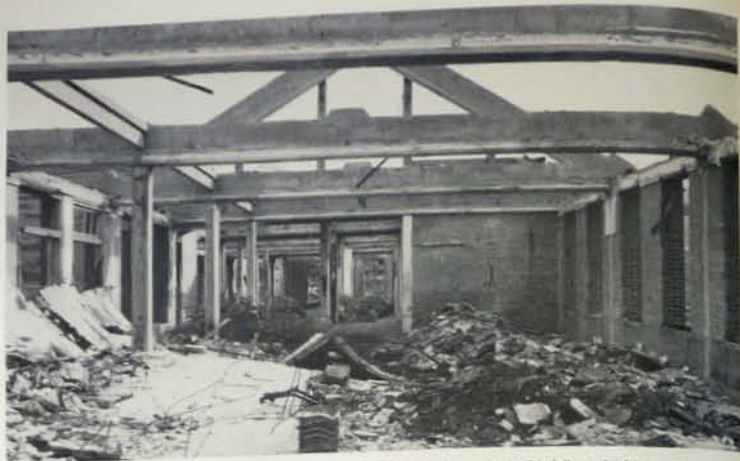
PHOTO 18.—4,800 feet from GZ. Group 7, Building 1, damage on third floor, looking east.

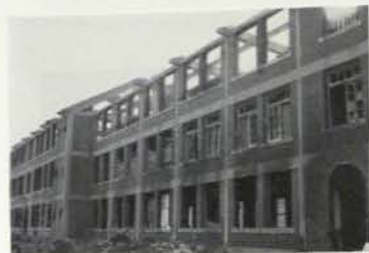
PHOTO 19.—Group 7, Building 1, looking southeast at north wall.

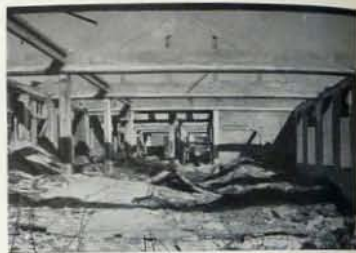
PHOTO 20.—Group 7, Building 1, roof destroyed by fire, looking west at damage on third floor.

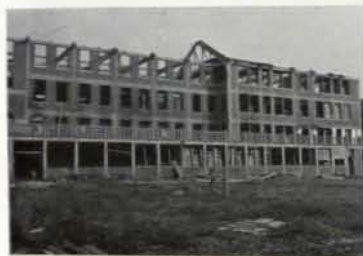
PHOTO 21.—Group 7, Building 1, looking northeast at south side.

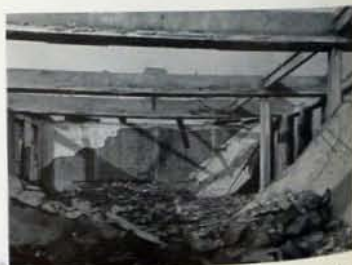
PHOTO 22.—Group 7, Building 1, looking west at damage on third floor.

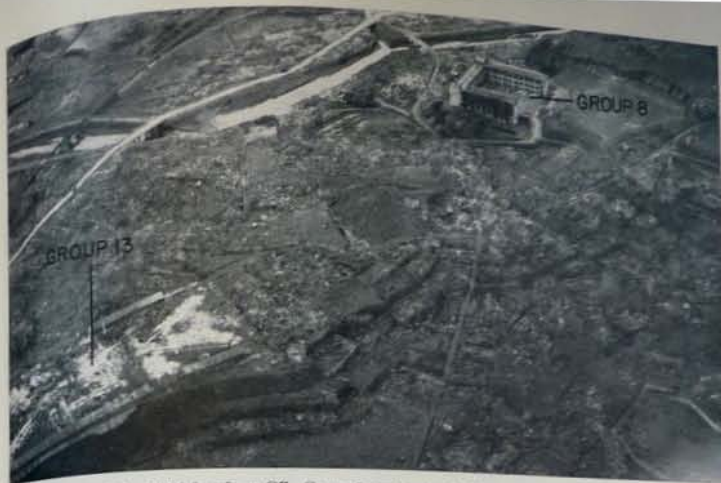
PHOTO 23.—2,200 feet from GZ. Group 8, aerial view looking north at Yamamoto School.

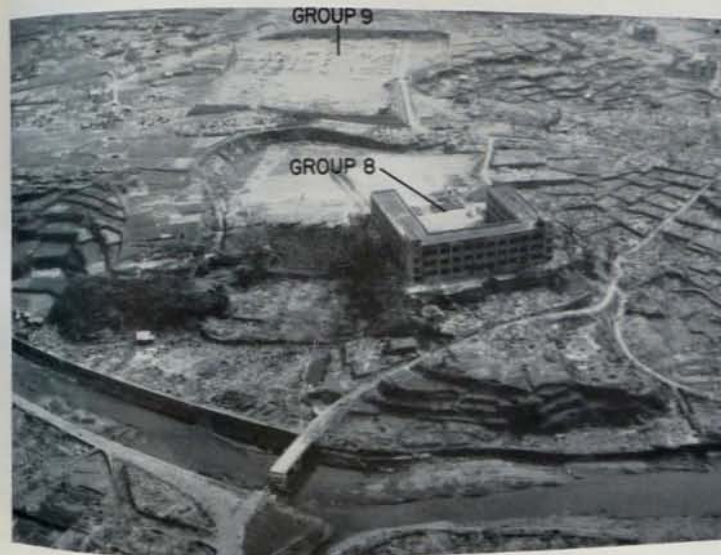
PHOTO 24.—2,200 feet from GZ. Group 8, aerial view looking east.

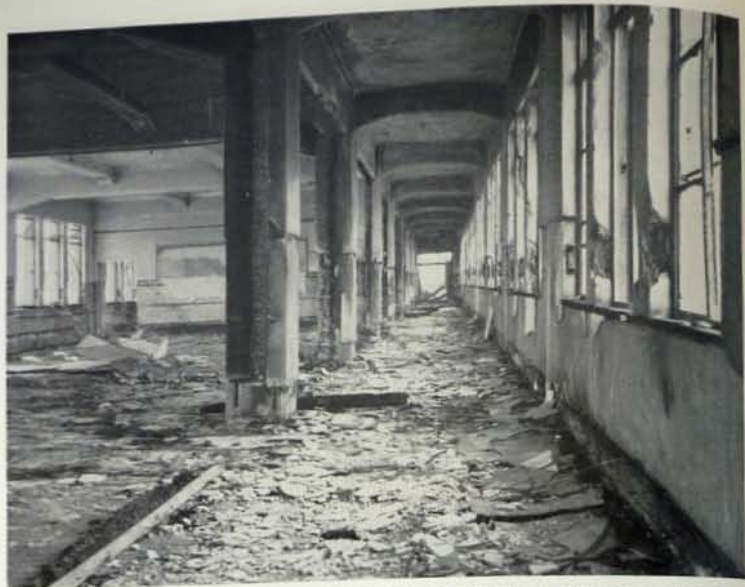
PHOTO 25.—2,200 feet from GZ. Group 8, Building 1, looking north at fire damage on second floor.

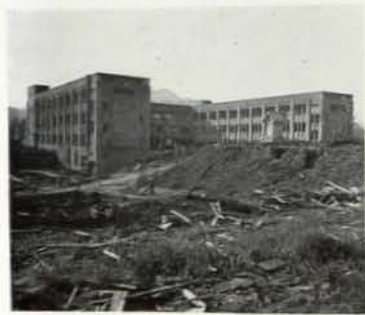
PHOTO 26.—Group 8, Building 1, general view, looking northwest.

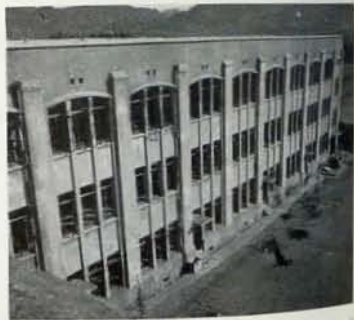
PHOTO 27.—Group 8, Building 1, south wall of north wing.

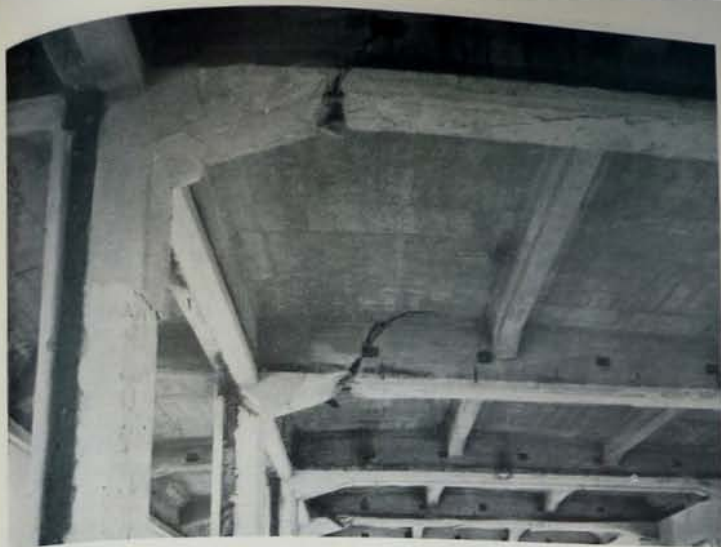
PHOTO 28.—2,200 feet from GZ. Group 8, Building 1, looking south at cracked roof beams in center wing.

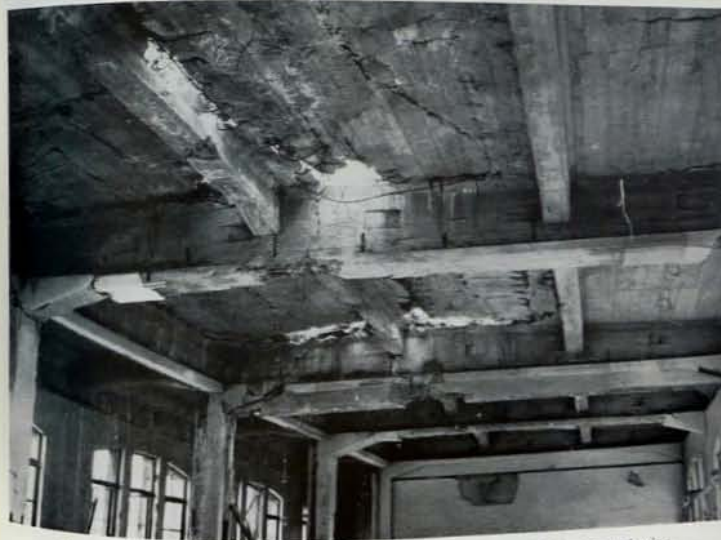
PHOTO 29.—Group 8, Building 1, looking northeast at roof from third floor of south wing.

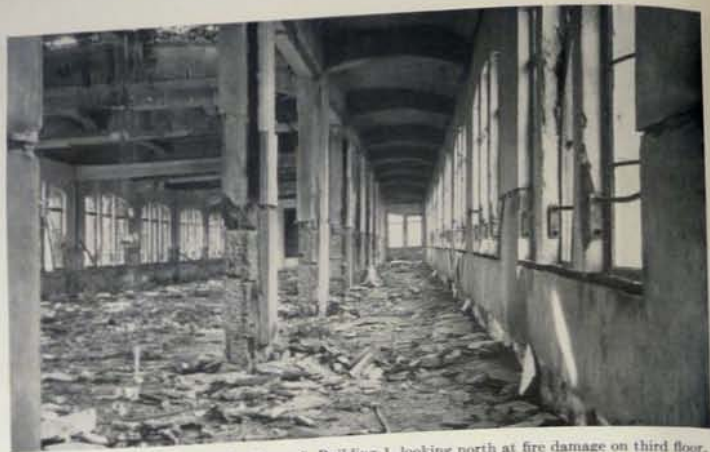
PHOTO 30.—2,200 feet from GZ. Group 8, Building 1, looking north at fire damage on third floor.

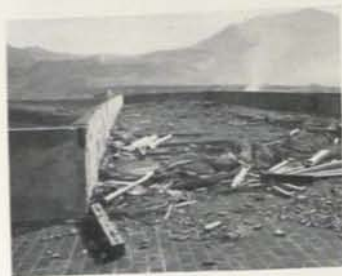
PHOTO 31.—Group 8, Building 1, deflected parapet wall on north side of south wing.

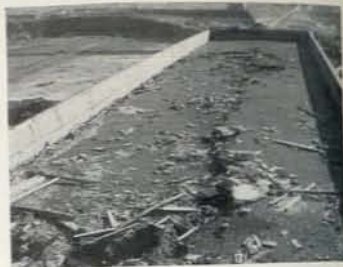
PHOTO 32.—Group 8, Building 1, cracked roof of south wing.

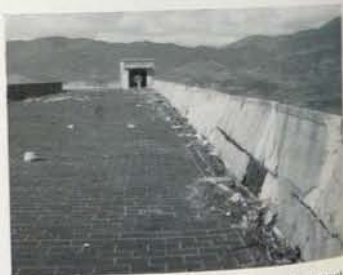
PHOTO 34.—Group 8, Building 1, deflected parapet wall on north side of north wing.

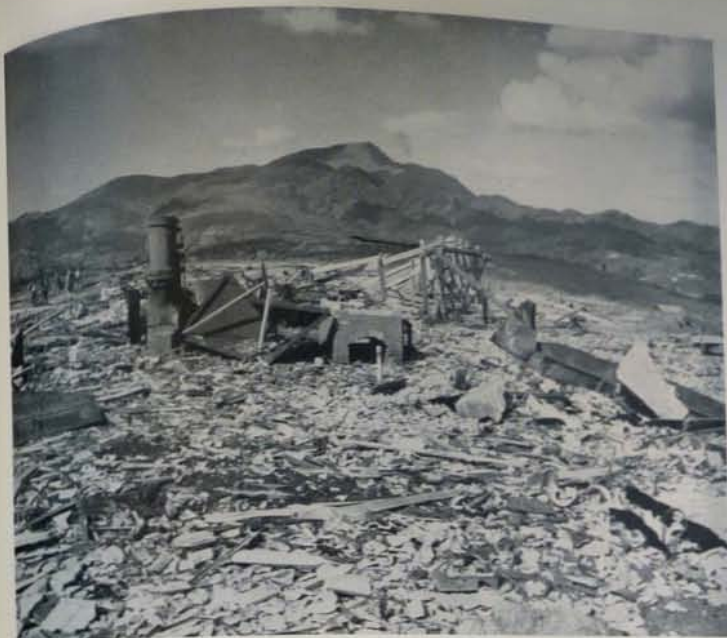
PHOTO 35.—2,500 feet from GZ. Group 9, Building 1, looking west at remaining debris.

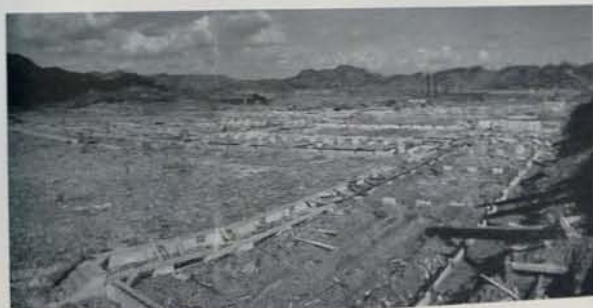
PHOTO 36.—Group 9, general view of debris, looking northwest.

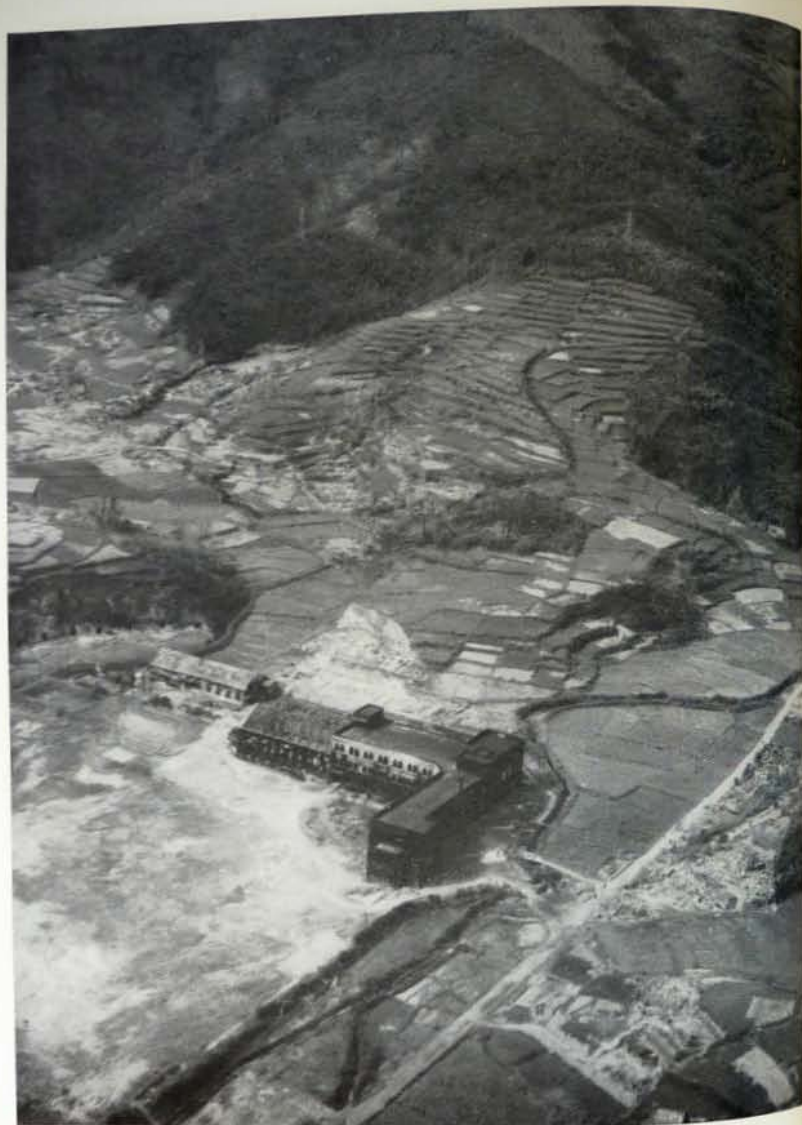
PHOTO 37.—3,600 feet from GZ. Group 10, aerial view looking north, Nagasaki Commercial School.

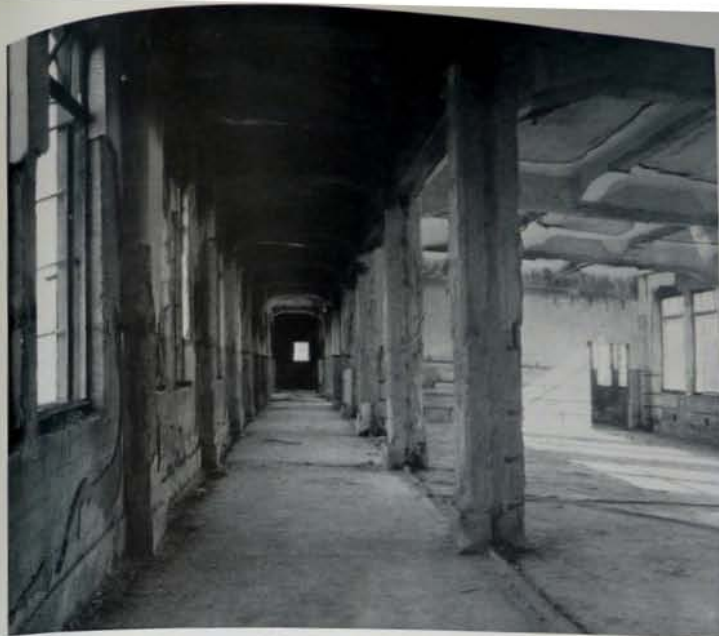
PHOTO 38.—3,600 feet from GZ. Group 10, Building 3, looking northeast on second floor.

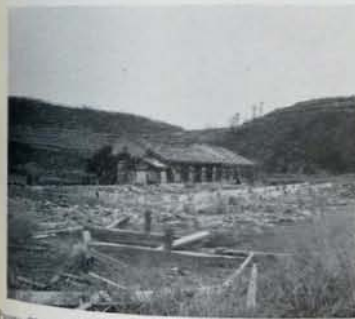
PHOTO 39.—Group 10, Building 8, general view looking south.

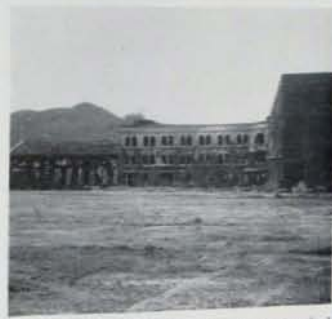
PHOTO 40.—Group 10, Building 3, general view looking west.

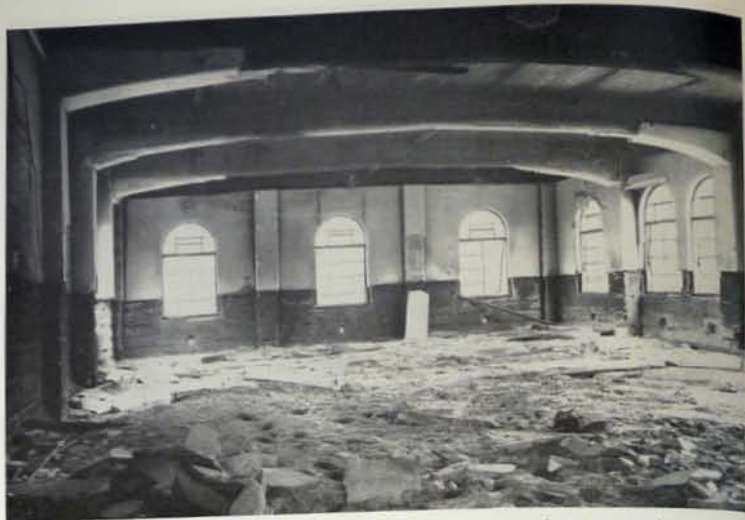
PHOTO 41.—3,600 feet from GZ. Group 10, Building 3, looking southwest on second floor.

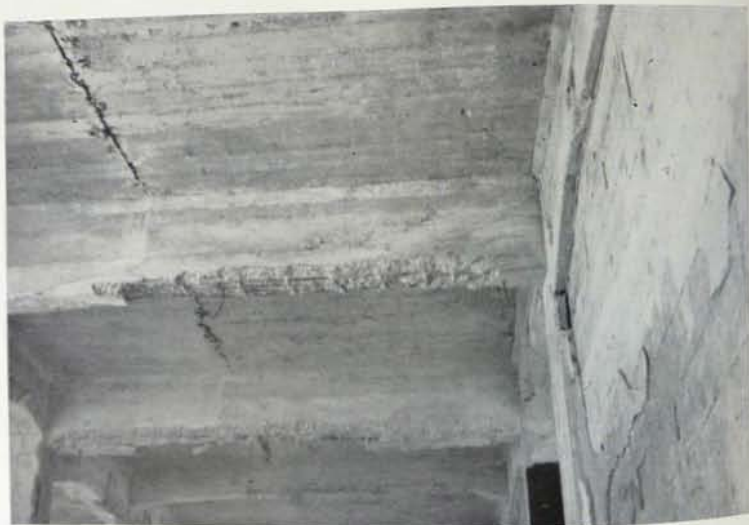
PHOTO 42.—3,600 feet from GZ. Group 10, Building 3, cracked roof slab and beams, looking east in south wing

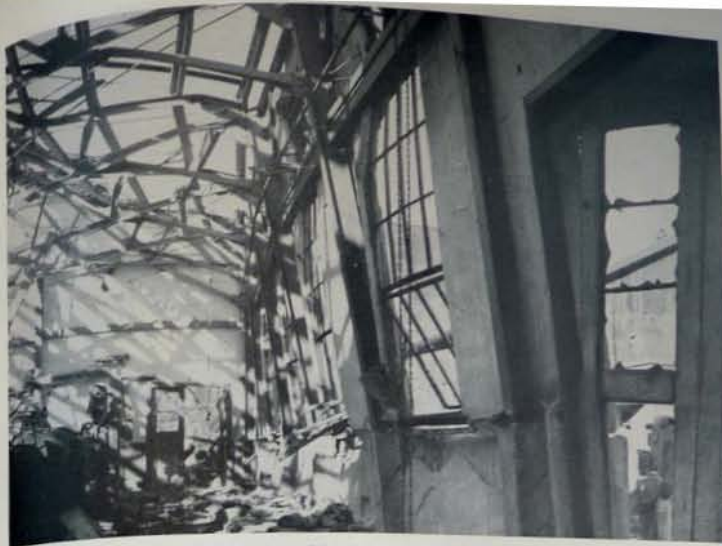
PHOTO 43.—3,600 feet from GZ. Group 10, Building 8, typical column failure.

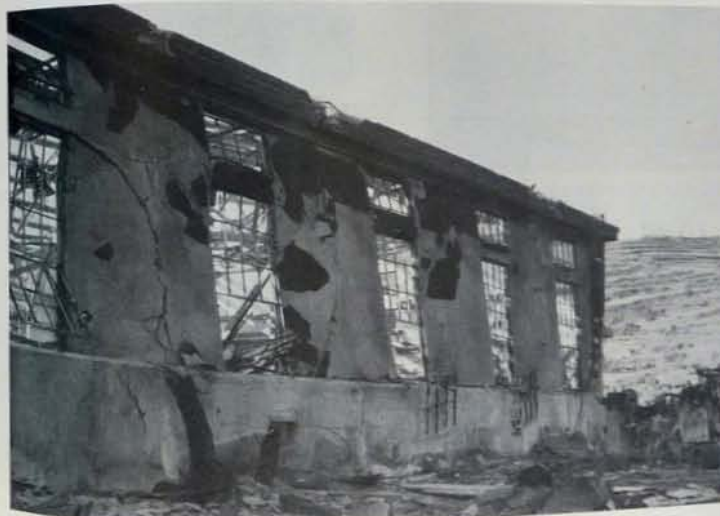
PHOTO 44.—Group 10, Building 8, failure at east wall.

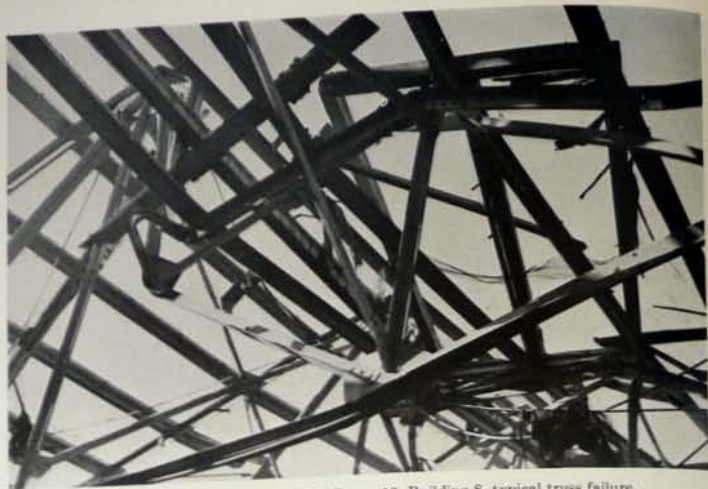
PHOTO 45.—3,600 feet from GZ. Group 10, Building 8, typical truss failure.

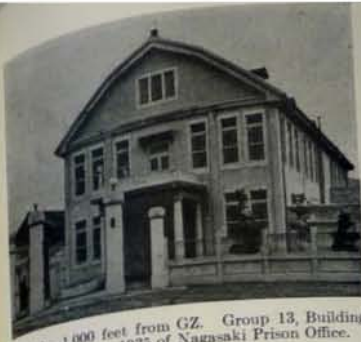
PHOTO 50.—1,000 feet from GZ. Group 13, Building 2, photo taken in 1935 of Nagasaki Prison Office.

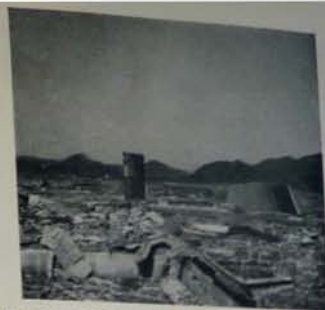
PHOTO 51.—1,000 feet from GZ. Group 13, general view looking northeast across prison grounds.

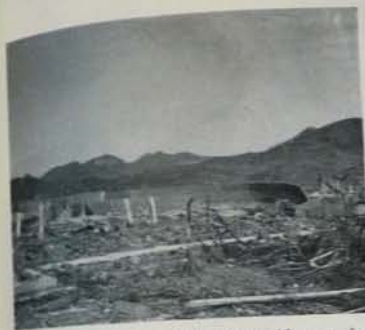
PHOTO 52.—1,000 feet from GZ. Group 13, general view looking north. Part of prison wall remains standing.

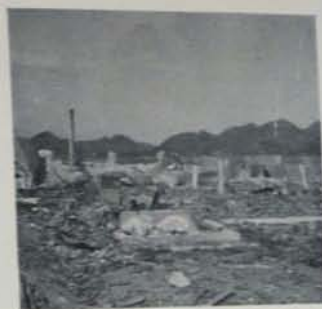
PHOTO 53.—1,000 feet from GZ. Group 13, view of debris of cell blocks.

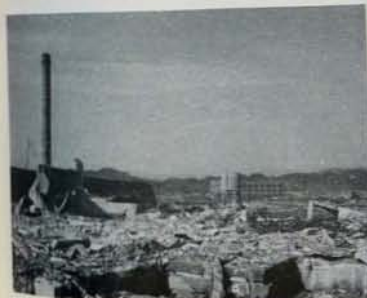
PHOTO 54.—1,000 feet from GZ. Group 13, debris of office building in foreground; concrete stack remains standing at left of photo.

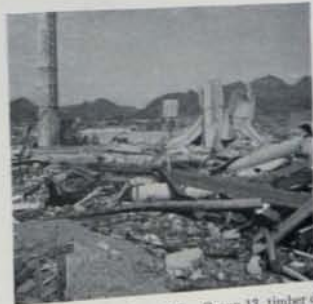
PHOTO 55.—1,000 feet from GZ. Group 13, timber debris in foreground only unburned wood at the site.

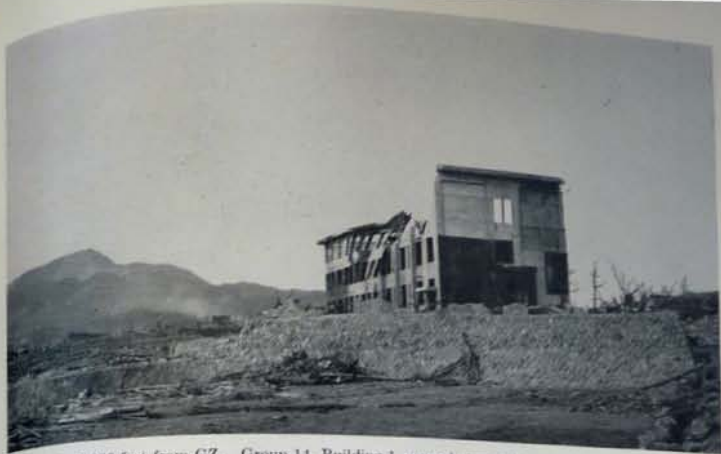
Photo 57.—1,900 feet from GZ. Group 14, Building 1, general view looking northwest at school building.

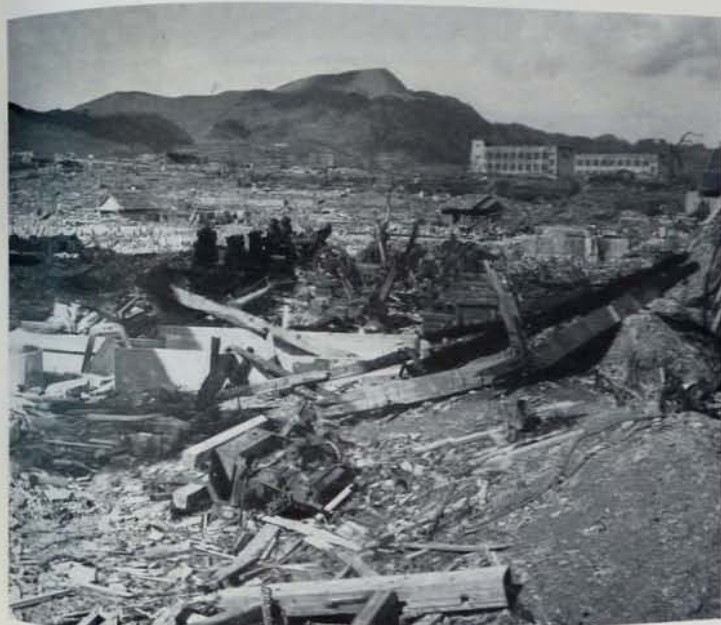
Photo 58.—1,900 feet from GZ. Group 14, Building 3, charred remains of wooden structure. Machine tools in photo were housed in this building.

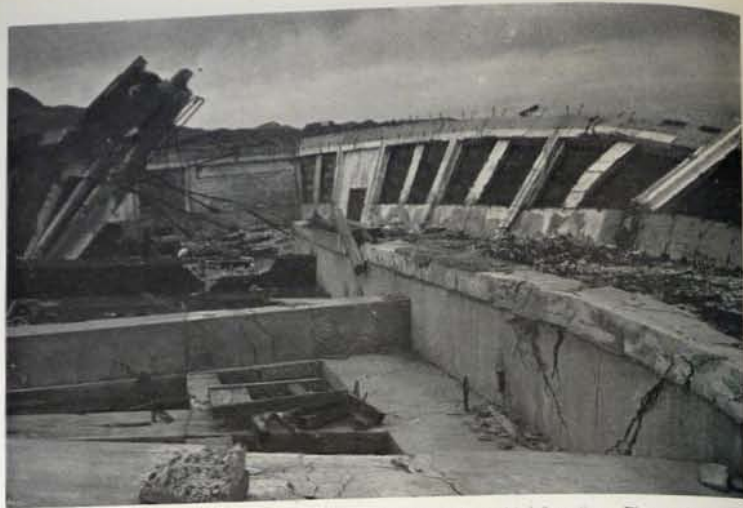
Photo 59.—Group 14, Building 1, north wall broken and leaning north at third-floor line. Photo taken from top of debris of south wall collapsed on third floor.

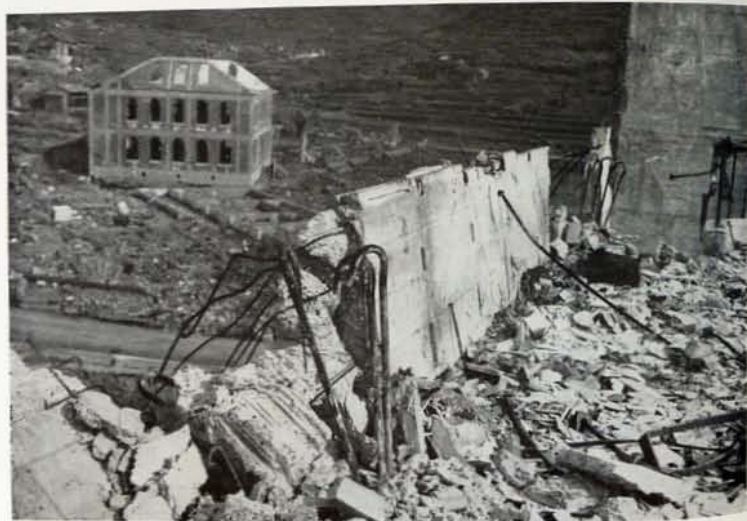
Photo 60.—Group 14, Building 1, exposed reinforcing steel in column 8D at third-floor level, Building 3 (Group 15) in upper left corner of photo.

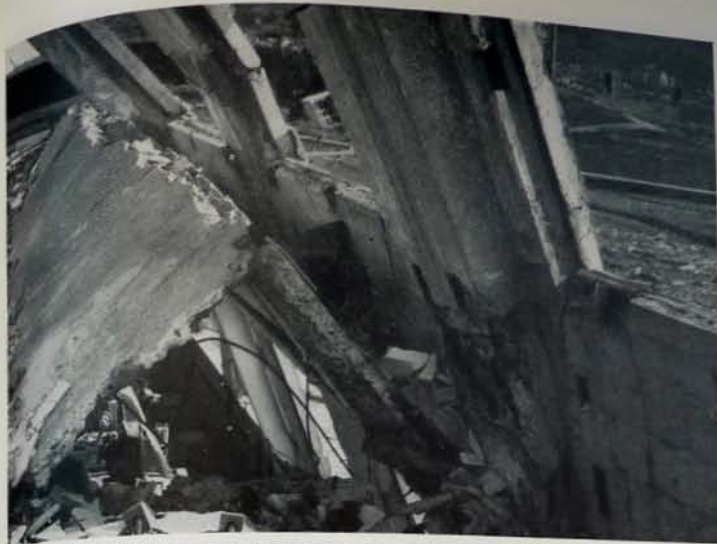
Photo 61.—Group 14, Building 1, looking southeast at Column 5A above third-floor line. Third-floor slab buckled upward.

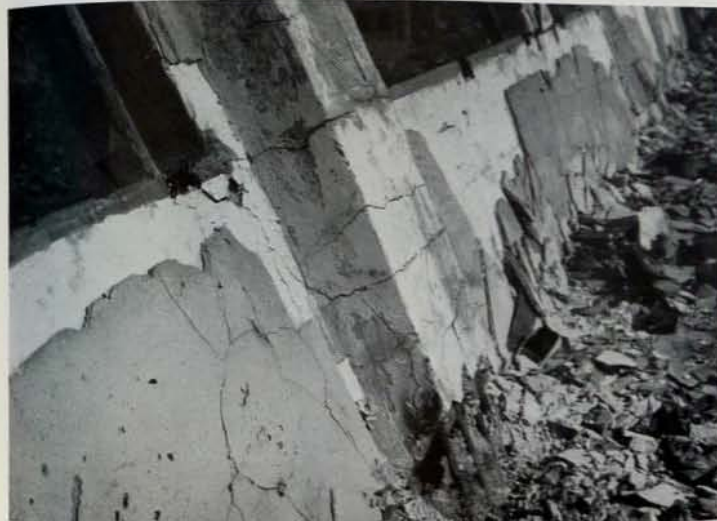
Photo 62.—Group 14, Building 1, looking northeast at north wall leaning north at third-floor line. Column 4D in foreground.

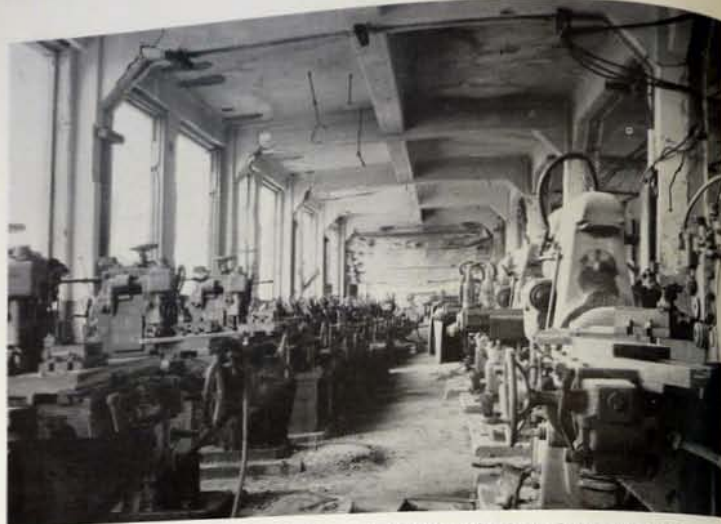
Photo 63.—Group 14, Building 1, looking west on first floor showing undamaged machines.

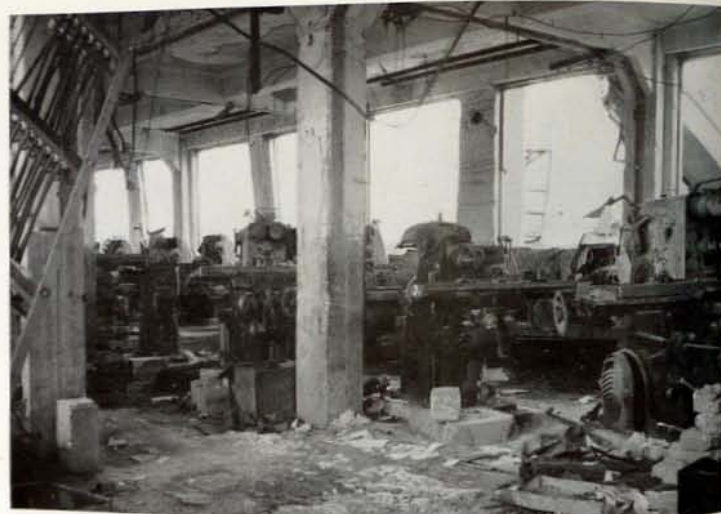
Photo 64.—Group 14, Building 1, interior view looking northwest on first floor. Concrete column at upper right has fallen from third floor.

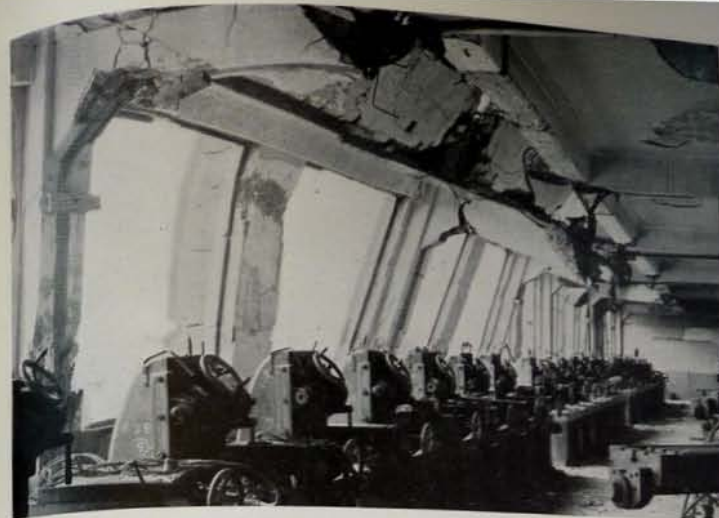
Photo 65.—Group 14, Building 1, interior view looking west on second floor showing fractured third-floor beams.

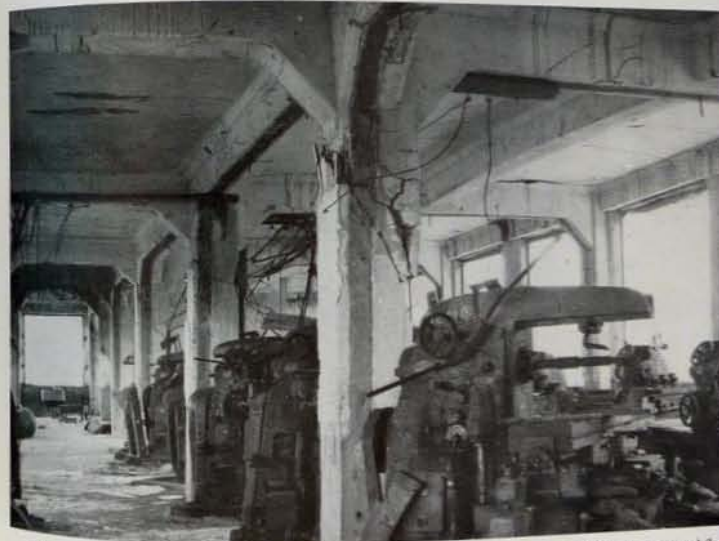
Photo 66.—Group 14, Building 1, looking northwest at Column 6B shattered 8 feet above second floor.

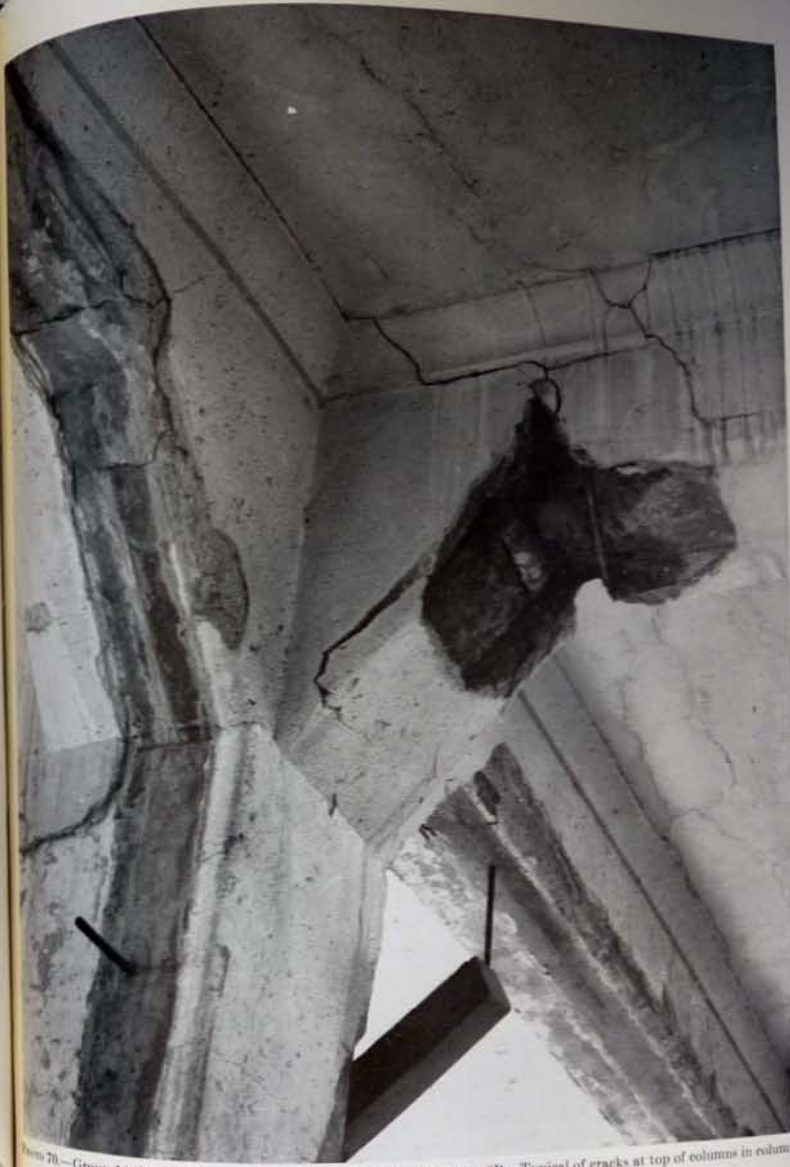
Photo 70.—Group 14, Building 1, looking southwest at top of Column 6B. Typical of cracks at top of columns in column rows B and C.

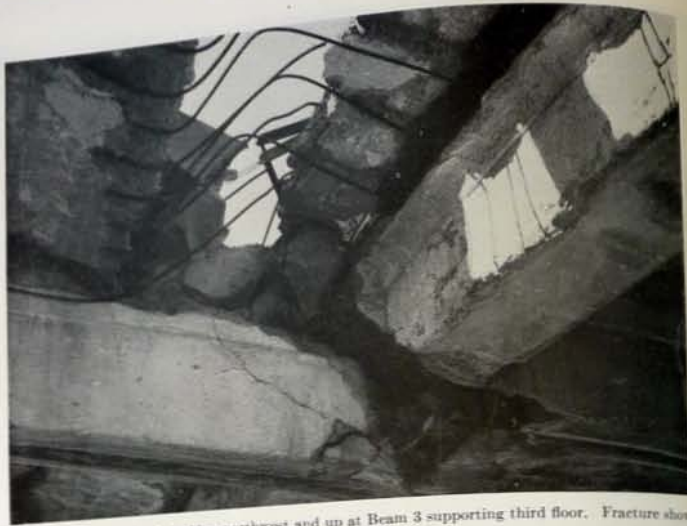
PHOTO 71.—Group 14, Building 1, looking northwest and up at Beam 3 supporting third floor. Fracture shown is 9 ft from south wall.

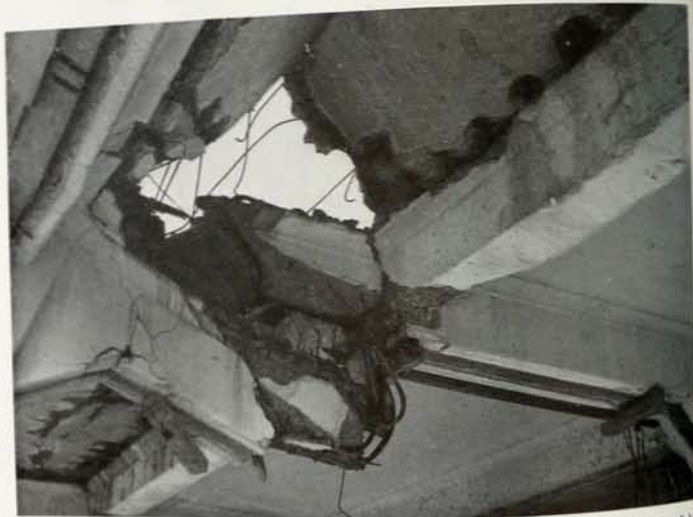
PHOTO 72.—Group 14, Building 1, looking northwest and up at Beam 5 supporting third floor. Typical of beam failure adjacent to south wall in Beams 3, 5, 6, and 7.

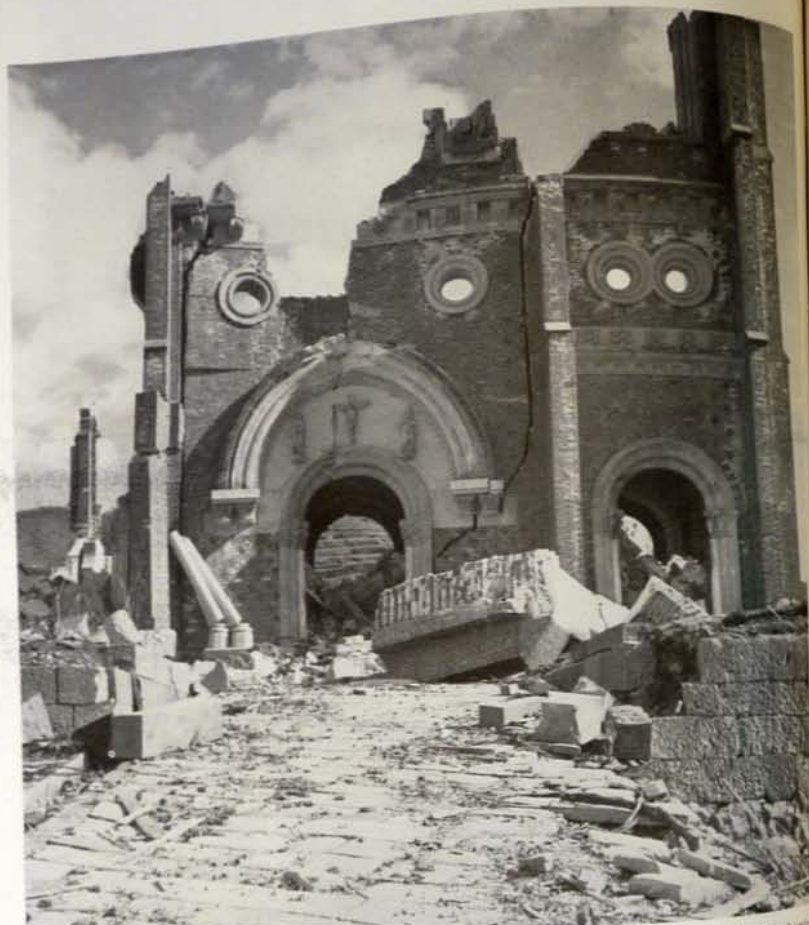
Photo 77.—1,800 feet from GZ. Group 15, Building 1, looking west at ruins of cathedral. Note concrete dome blasted from west tower and resting in center of debris.

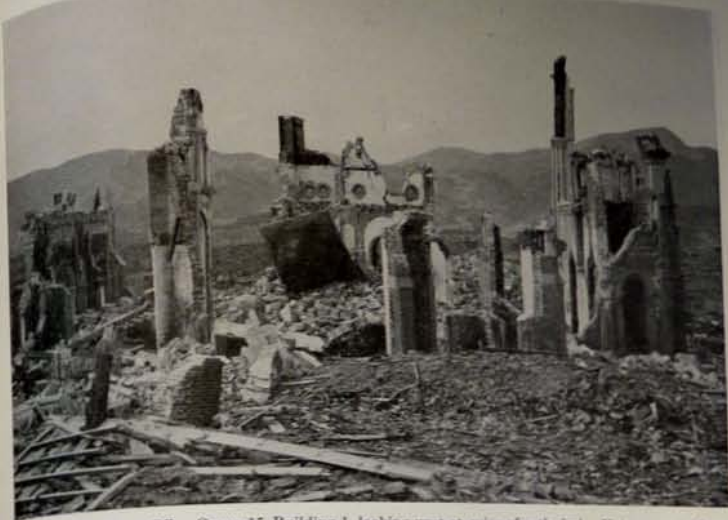
Photo 78.—Group 15, Building 1, looking northeast at remains of south wall of cathedral.

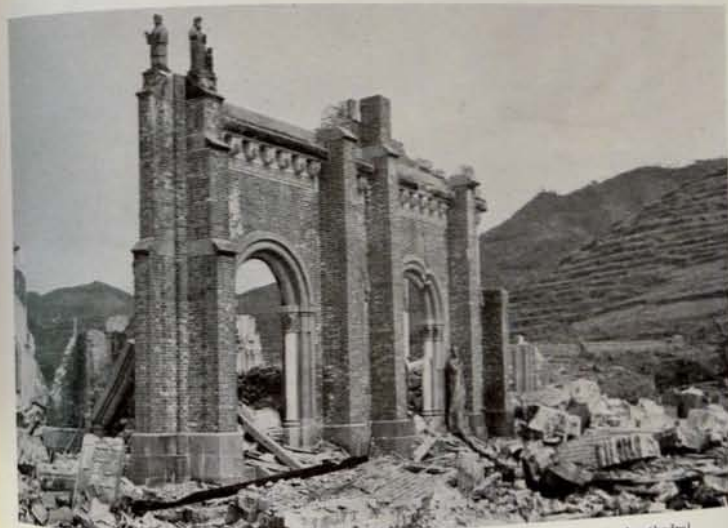
PHOTO 79.—Group 15, Building 1, concrete dome from southwest tower fallen into debris of building.

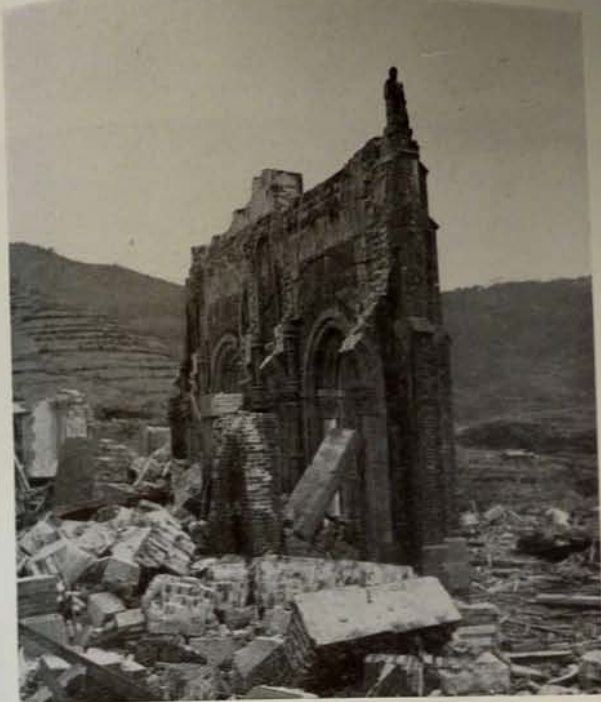
PHOTO 82.—2,200 feet from G.Z. Group 15, Building 3, view looking north showing roof burned away and leaning gable walls.

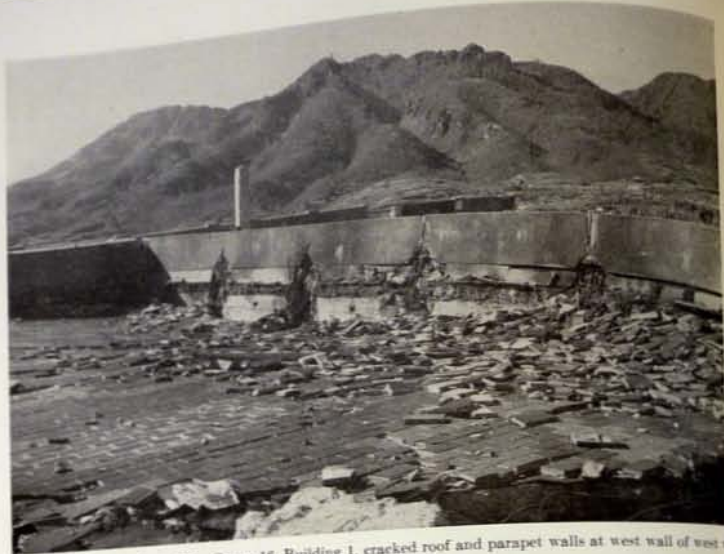
Photo 87.—1,600 feet from GZ. Group 16, Building 1, cracked roof and parapet walls at west wall of west wing.

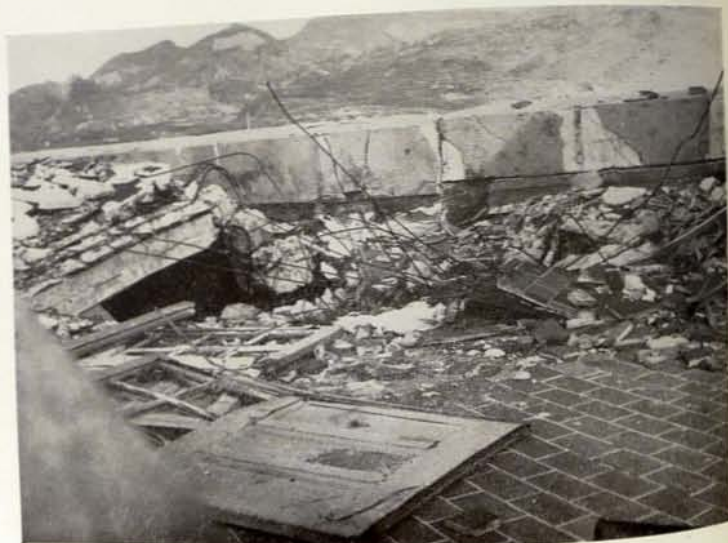
Photo 88.—Group 16, Building 1, roof Beam 21 thrust upward. See photo 97.

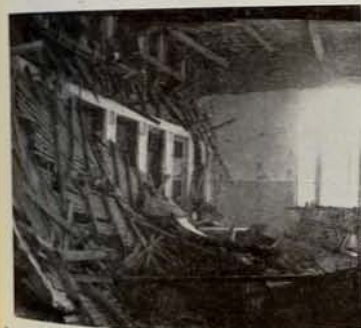
Photo 90.—Group 16, Building 1, small area not damaged by fire on third floor.

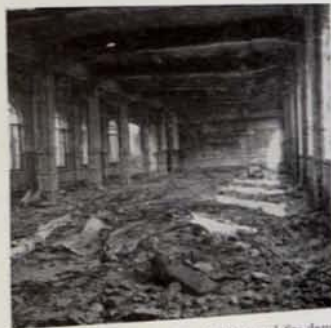
Photo 91.—Group 16, Building 1, blast and fire damage on third floor, center wing.

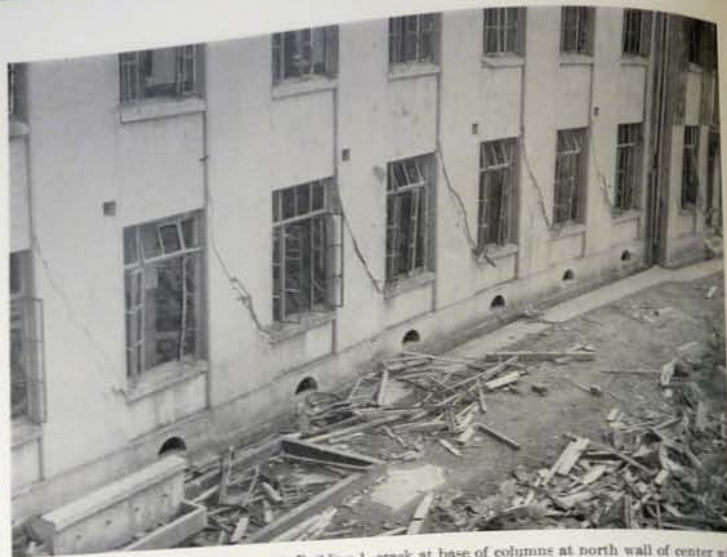
PHOTO 92.—1,600 feet from GZ. Group 16, Building 1, crack at base of columns at north wall of center wing.

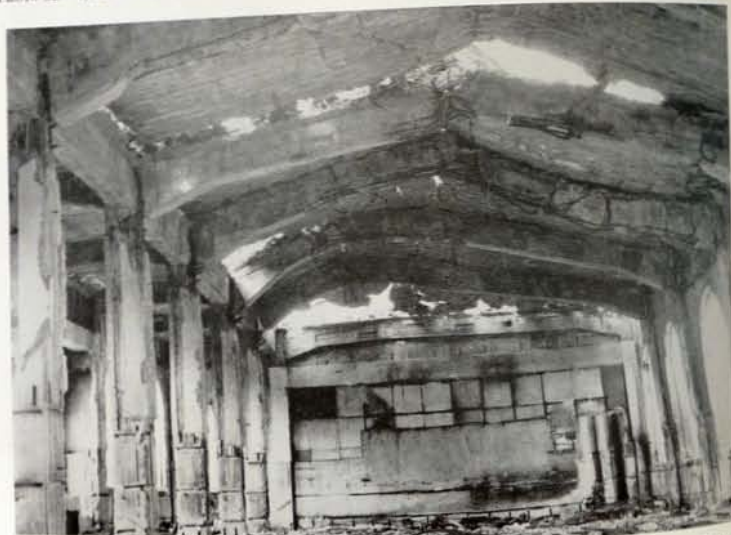
PHOTO 93.—Group 16, Building 1, looking north at cracked roof deflected upward in east wing. Beams 23, 24, 25, and 26 shown.

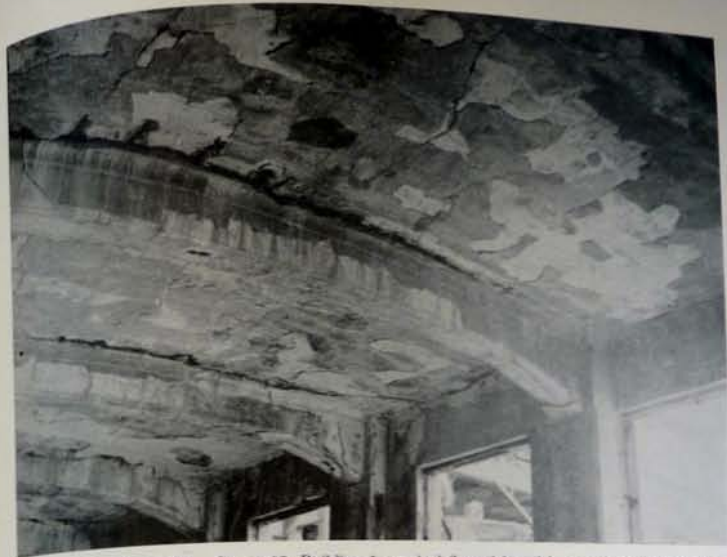
PHOTO 94.—1,600 feet from GZ. Group 16, Building 1, cracked floor slab and beams of second floor in west wing. Beams 2, 3, and 4 shown.

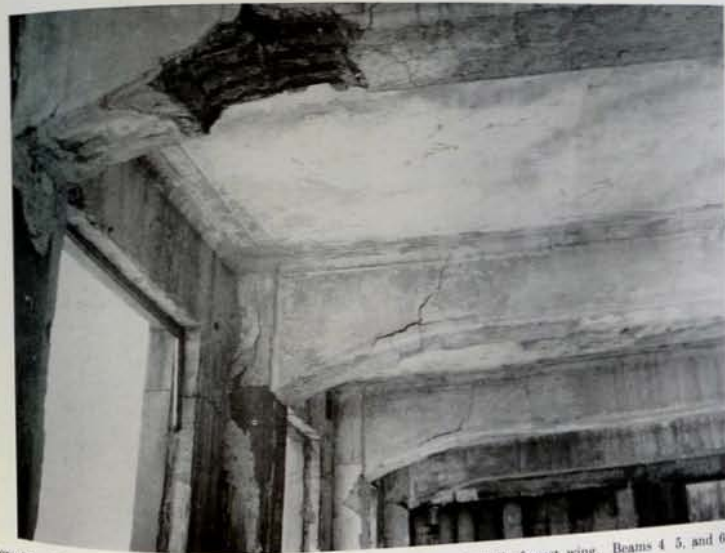
PHOTO 95.—Group 16, Building 1, cracked third floor beams at west wall of west wing. Beams 4, 5, and 6 shown.

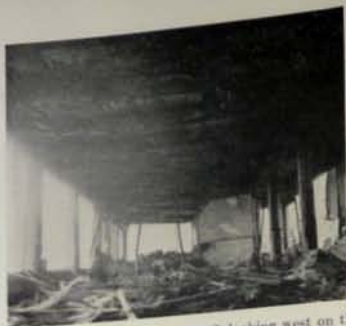
Photo 102.—Group 16, Building 2, looking west on third floor.

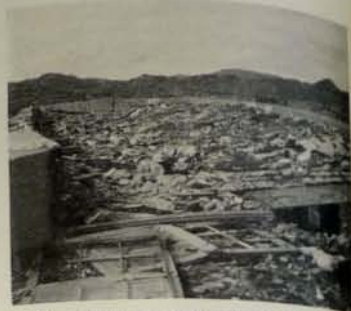
Photo 103.—Group 16, Building 1, looking north on roof of east wing, showing buckled roof slab.

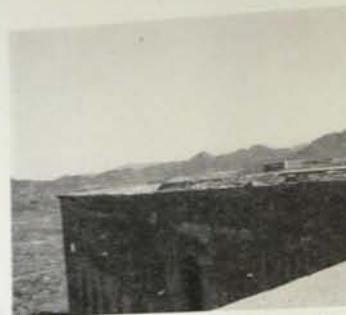
Photo 104.—Group 16, Building 1, west wall and roof of east wing.

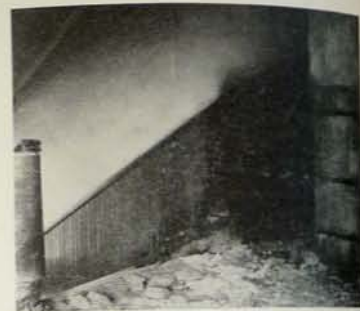
Photo 105.—Group 16, Building 1, fire damage at stair at east end of center wing.

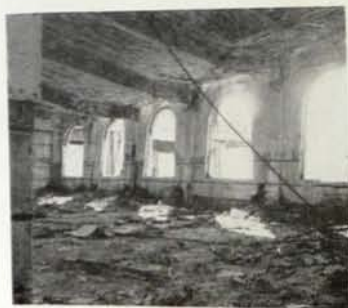
Photo 106.—Group 16, Building 1, fire and blast damage to third floor of west wing.

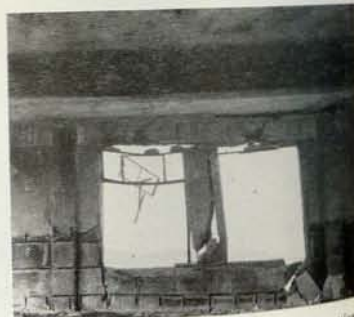
Photo 107.—Group 16, Building 1, interior view of cracked north wall at second floor, east wing.

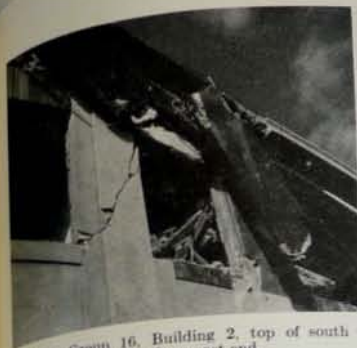
Photo 108.—Group 16, Building 2, top of south wall 30 feet from east end.

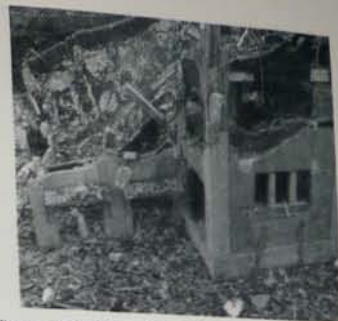
Photo 109.—Group 16, Building 2, looking south at collapsed east end.
